Unexpected aftercare caused by the simple stent technique

Yutaka HIKICHI,MD, Koichi NODE,MD,PhD Department of Cardiovascular Medicine, Saga University Saga, Japan

Case. 60's Male

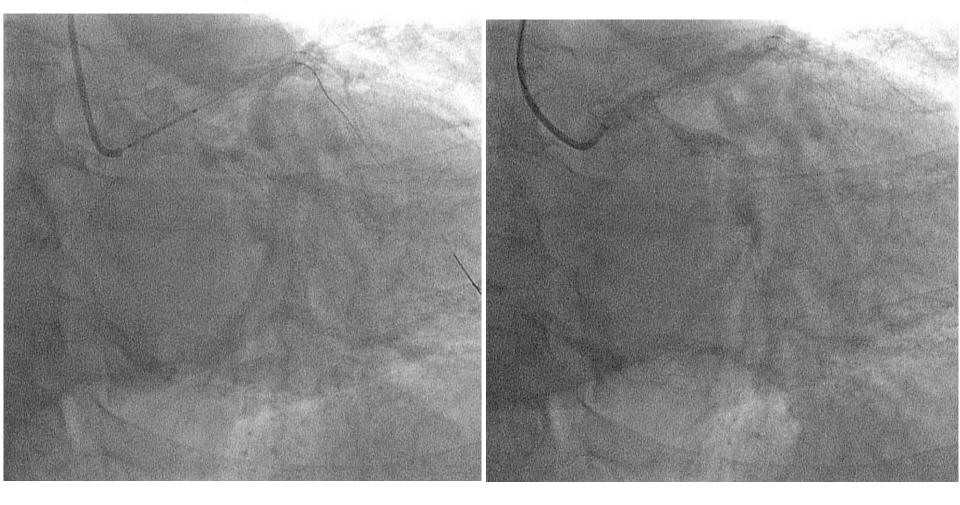
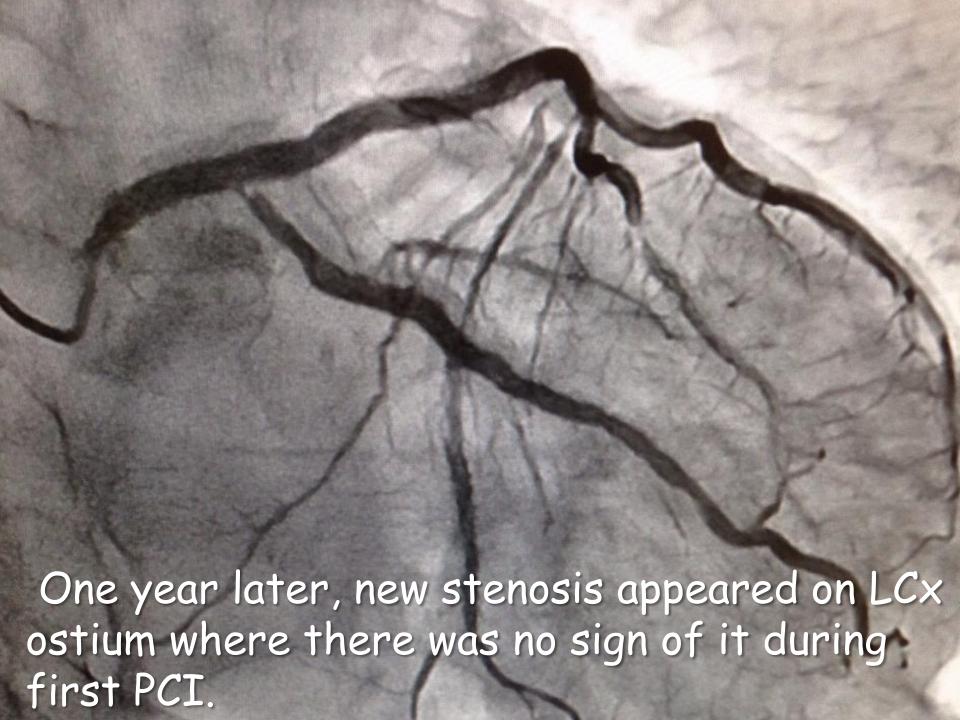
1st PCI more than one year ago

- One year ago, he had been implanted one Resolute Integrity stent from LMT to proximal LAD without POT or final kissing balloon dilatation (FKBD). The whole procedure was completed successfully.
- But recently, the chest discomfort and arrhythmia on exertion started to appear, therefore, we made an appointment of CAG as to follow-up this patient.

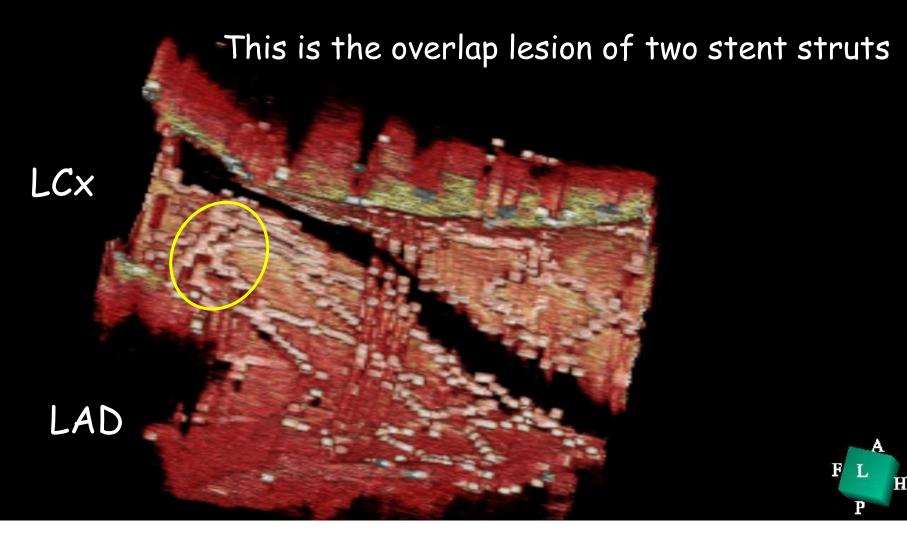
From this image, I found out that localized incomplete apposition occurred between 2 stents that are overlapped one another.
